# SURFACE WATER ANALYSIS IN EL ASTILLERO

SURFACE WATER QUALITY AND SAFETY ASSESSMENT IN THE VILLAGE  
OF EL ASTILLERO ACCORDING TO WORLD HEALTH ORGANISATION  
GUIDELINES

DAMIANO DUCI, MSC ENVIRONMENTAL SCIENCES, AQUATIC ECOLOGY AND  
WATER QUALITY MANAGEMENT (DUCI.DAMIANO@GMAIL.COM)

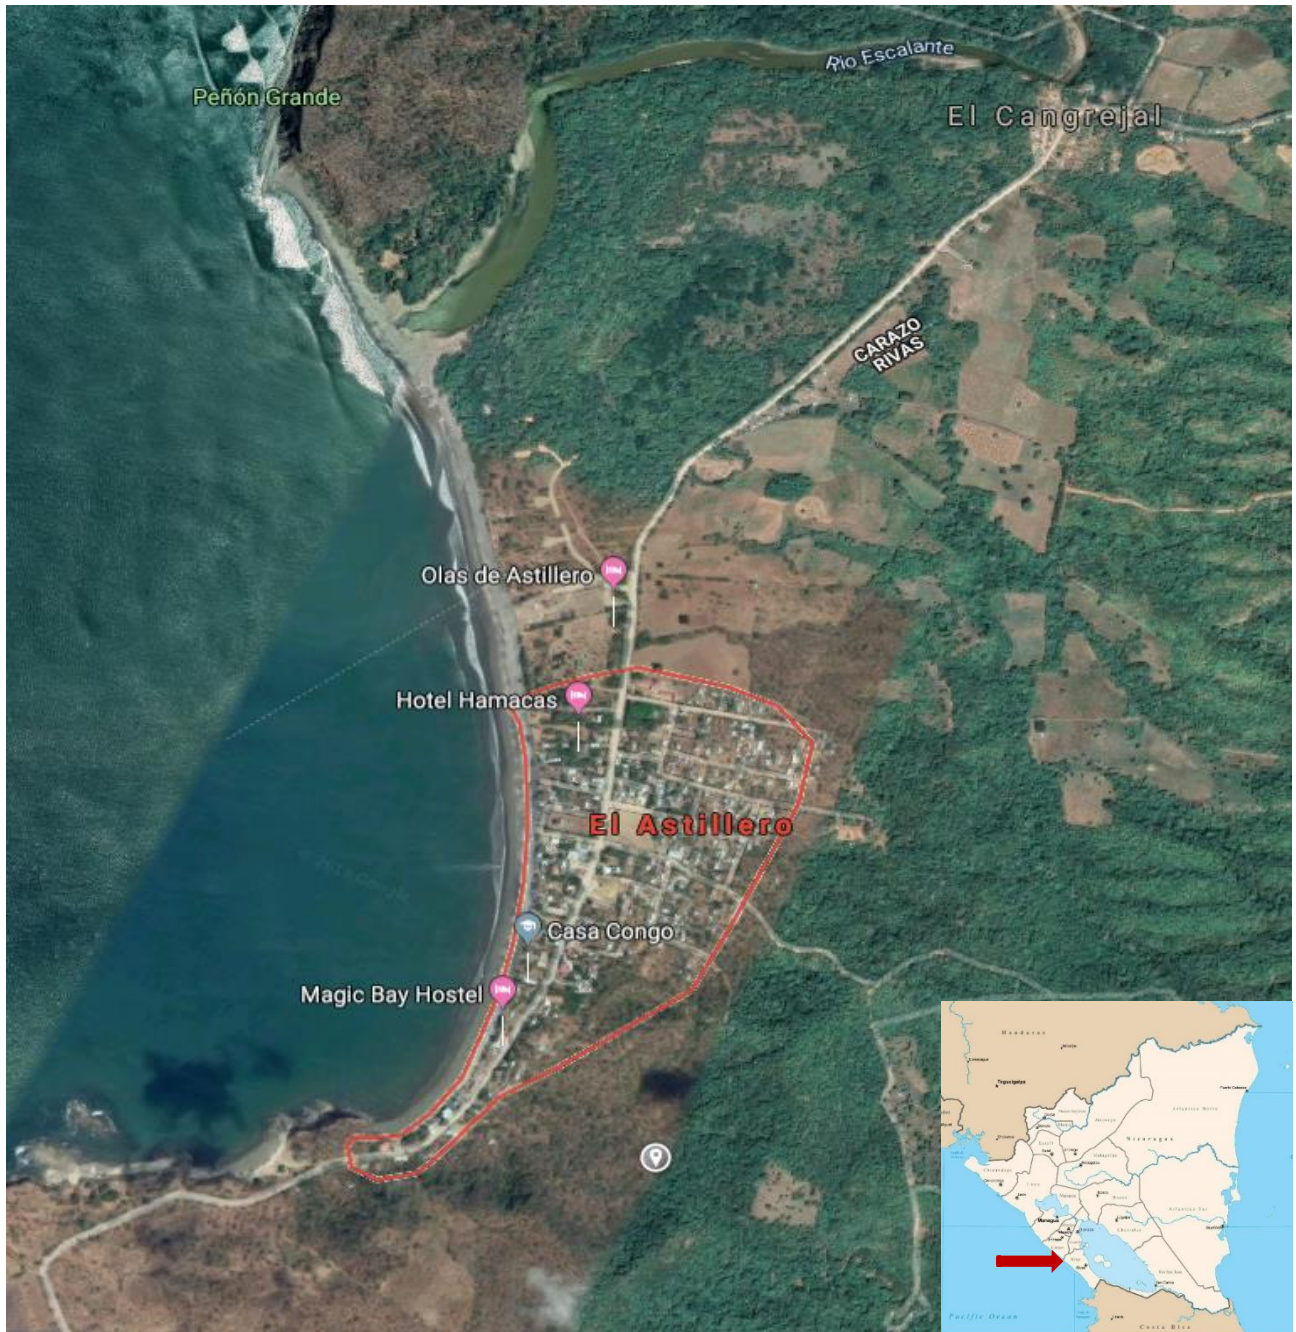
Figure 1. El Astillero (Nicaragua), area of interest. Casa Congo is indicated in the centre of the village. North of the village the river Rio Escalante. South of the village the water tank infrastructure is indicated by a grey pinpoint. Snapshot taken from google earth imagery and map resources.com.

Casa Congo is a NGO managed by locals with the goal to empower and improve the life quality of the people in the village and in the area. In collaboration with Casa Congo, I intend to perform a general water quality analysis in the village of El Astillero (**fig.1**), in order to assess the quality and safety of the water. This preliminary water quality analysis will help advice on the improved water treatment infrastructure required by the local inhabitants of El Astillero. Therefore, this project will focus on assessing the potability and safety of the water sources present in the village, as well as providing insight over the eutrophication and contamination of the surface waters.

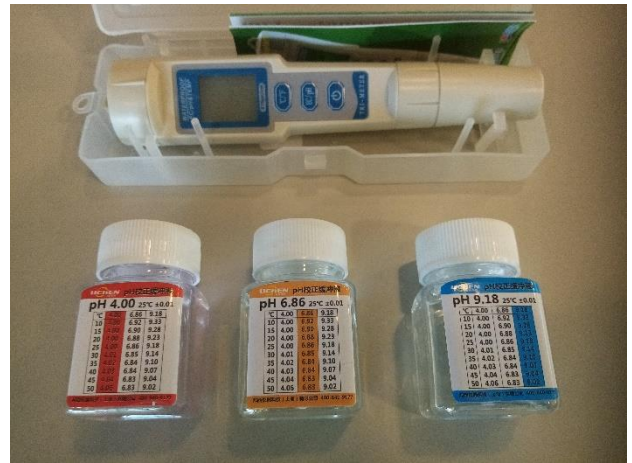
Figure 1 pH meter and buffer solutions (pH 4-6.86-9.18).

-**pH** and **EC** are measured with the pH-EC meter EC-3587 from *RoHS* (fig.2). The instrument is calibrated before use with the two point calibration method. Also, measurements are taken at the location marked with the Garmin 64s GPS.

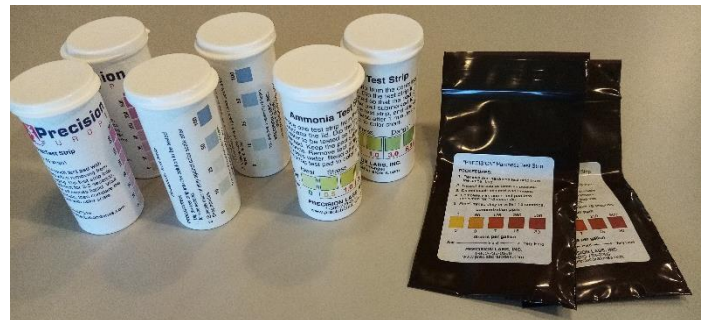
Figure 3 Nutrient strips for nitrate, phosphate, ammonia and water hardness.

-**Water Hardness, Phosphates, Nitrates and Ammonia** are measured with test strips from *Precision Lab Europe* (fig.3).

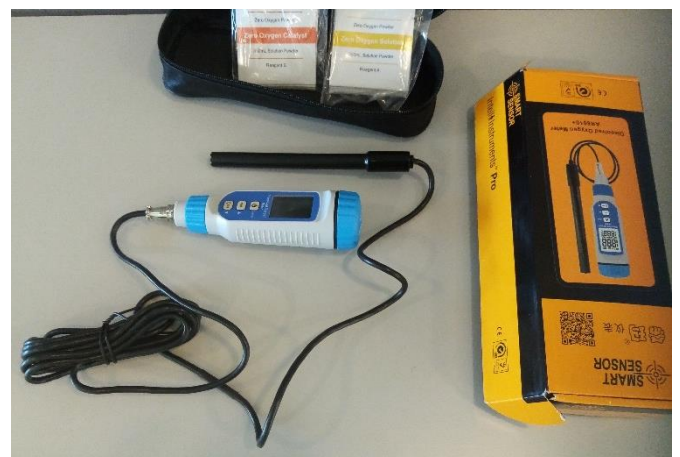
Figure 4 Oxygen meter.

- **Dissolved Oxygen** is measured with DO Meter AR 8010 Smart Sensor from *Intell Instruments™ Pro* (fig.4). This instrument is calibrated with a two point calibration method. Measurements are taken three times per sample and the average will be considered.

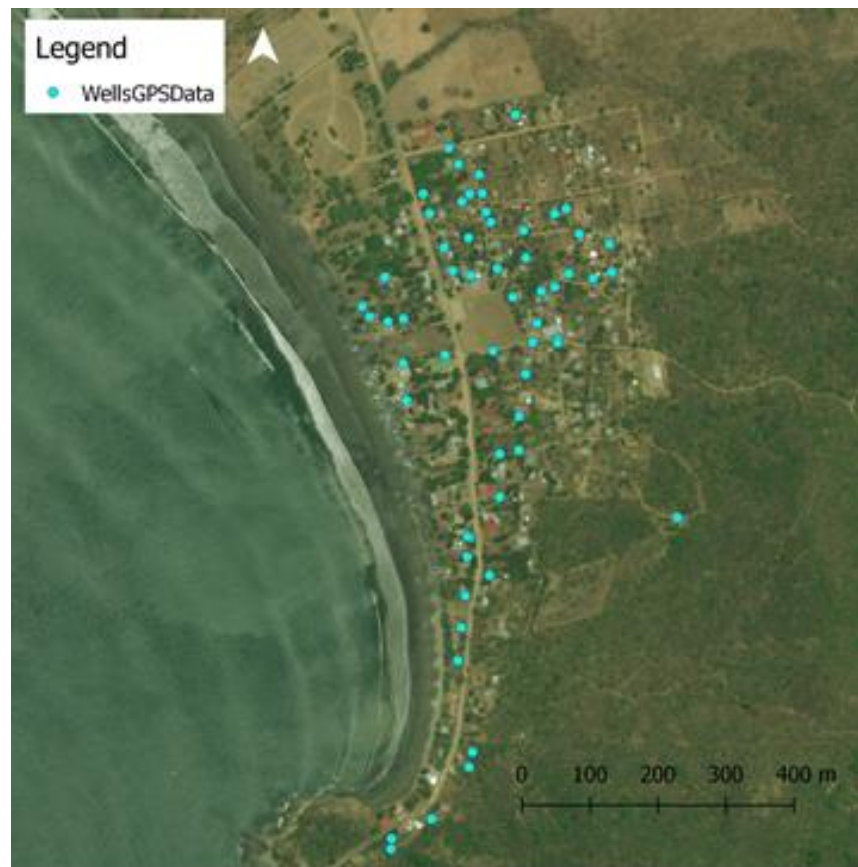
Figure 6. Wells sampled in the village of El Astillero. GPS location taken with Garmin64s. Bing aerial Image

In the village of El Astillero 60 Wells were geographically marked with a Garmin 64s GPS and measured for water quality parameters. The data collected from the wells is analysed with QGIS and with Sigmaplot. Results of the wells analysis are considered for each parameter. The spatial distribution of the wells shows a dense cluster in the north side of the village. Instead, in the central-south side of the village wells measured are located along the road (**fig.2**).

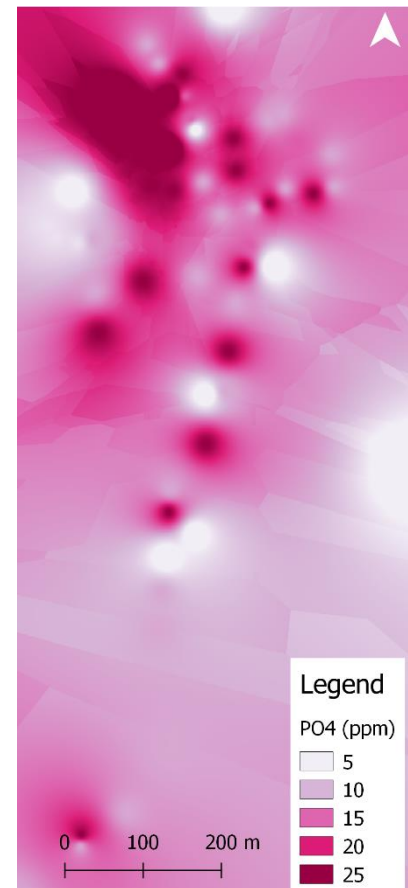
Figure 11 Phosphate Inverse Distance Weighted interpolation (IDW). Spatial analysis of the Wells measurement points.

The spatial analysis of the Phosphate reveals presence of phosphate overall in the area on average 16.25 ppm (**tab.2**). Furthermore, the spatial analysis reveals in the North West area of El Astillero a pocket with high concentration of 25 ppm (**fig.11**).

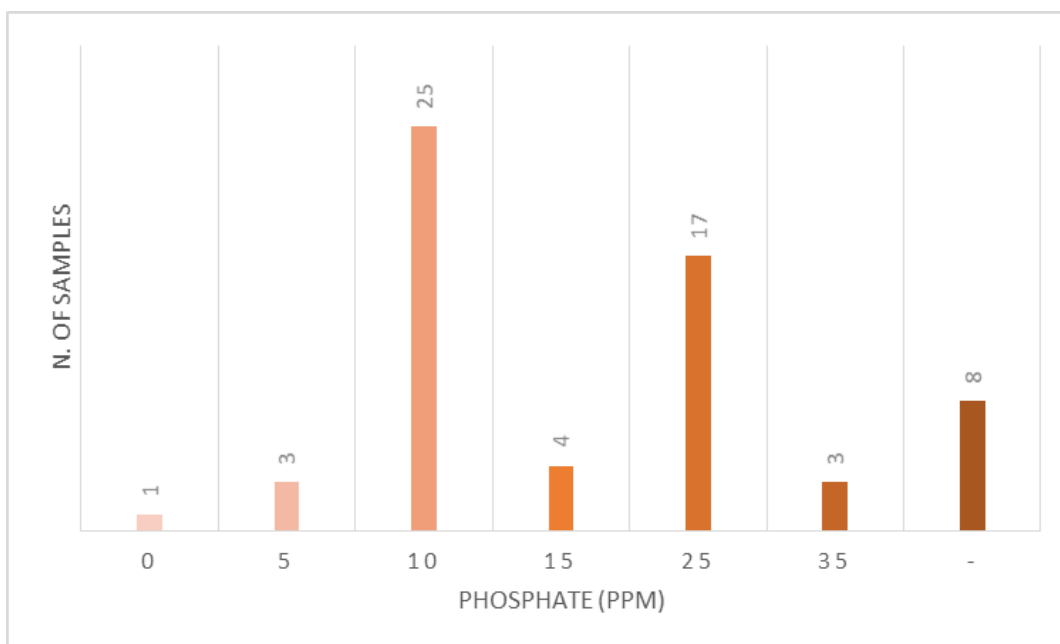
Figure 12. Frequency distribution of Phosphate samples

The frequency distribution reveals that 55% of the samples contain 10 ppm of  $\text{PO}_4$ , 28.3% contain 25 ppm, 13% could not be measured, 6% contained 15 ppm, 2% contained 35 ppm and 5 ppm each and 1% did not contain any phosphate (**fig.12**). The 13% of samples could not be measured due to the wells being sealed and not in use.

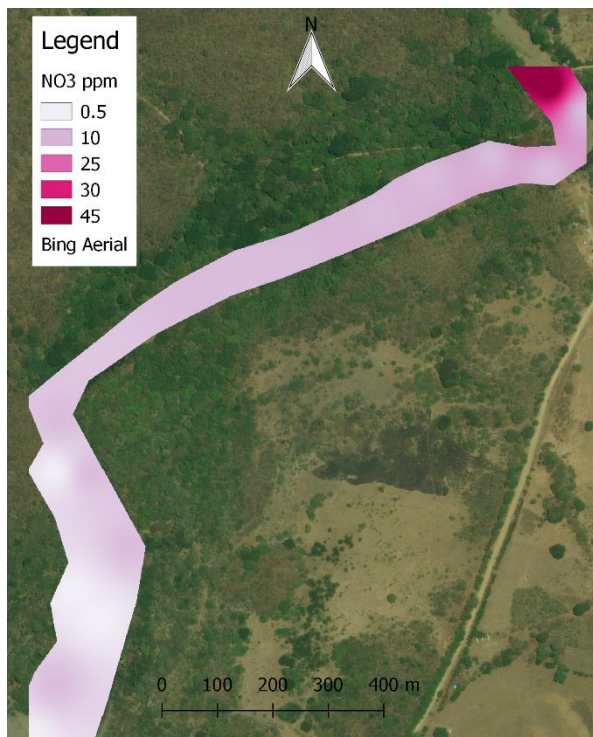
Figure 15. Nitrate Inverse Distance Weighted Interpolation (IDW). Spatial analysis of the Rio Escalante sampled points. Bing aerial Image

The minimum value measured was 0 ppm and the maximum concentration spike point (45ppm) is measured in the Cangrejal area, where some cattle animals few meters upstream from the measurement points were drinking and bathing in the river (**fig.15**).

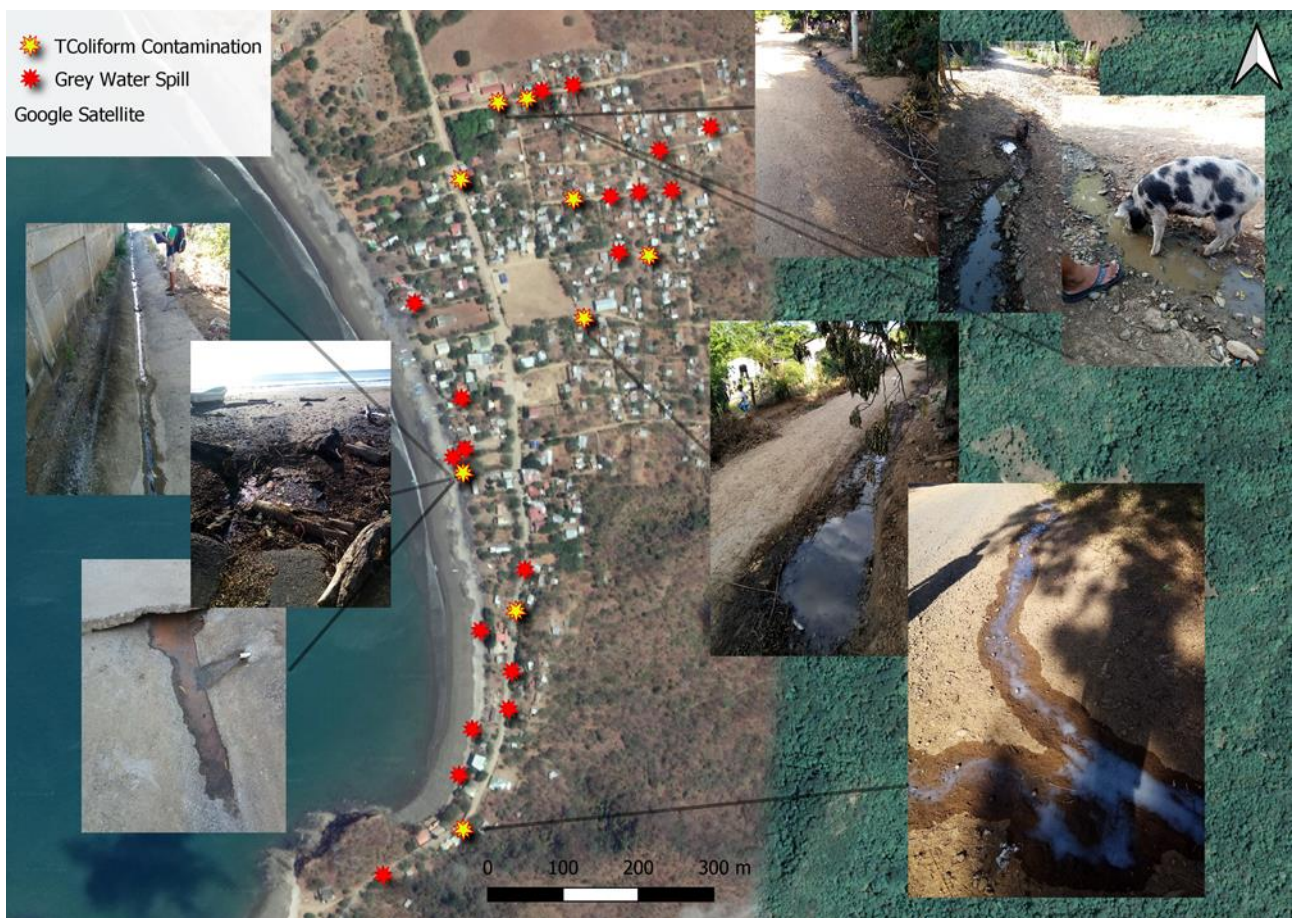
Figure 18. Grey water spill locations are labelled in red and in yellow the tested samples that revealed to be contaminated by Total Coliform.

Then, the GPS locations where a grey water spill was found are marked with the Garmin 64s, then 10 locations are chosen evenly distributed around the village for the Total Coliform presence test (**fig18**). Finally, 100% of the samples tested, revealed Total Coliform contamination in the grey water (**appendix D**).

Concerning the grey waters 28 locations were found where contaminated water was spilling directly on the road (**fig.18**). Also, 100% of the samples tested revealed Total Coliform contamination in this water spill locations. Coliform contamination poses a threat to every person and animal that comes in contact with puddles created by the identified spills (*Temple, K. L et al. 1982*). Indeed, cows, pigs and chickens that regularly drink this water are infected by the bacteria, which can then be transmitted to humans through consumption of animal products (*Hameed, K. G. A, 2007*) (*Anette M. Hammerum, Ole E. Heuer, 2009*). For instance, “*Escherichia coli*” bacteria transmitted through animals can develop antimicrobial resistance posing an additional threat to infected patients (*Anette M. Hammerum, Ole E. Heuer, 2009*). In conclusion, it is of the utmost importance for the village of El Astillero to make available a sewage system, a grey water collection and depuration infrastructure.

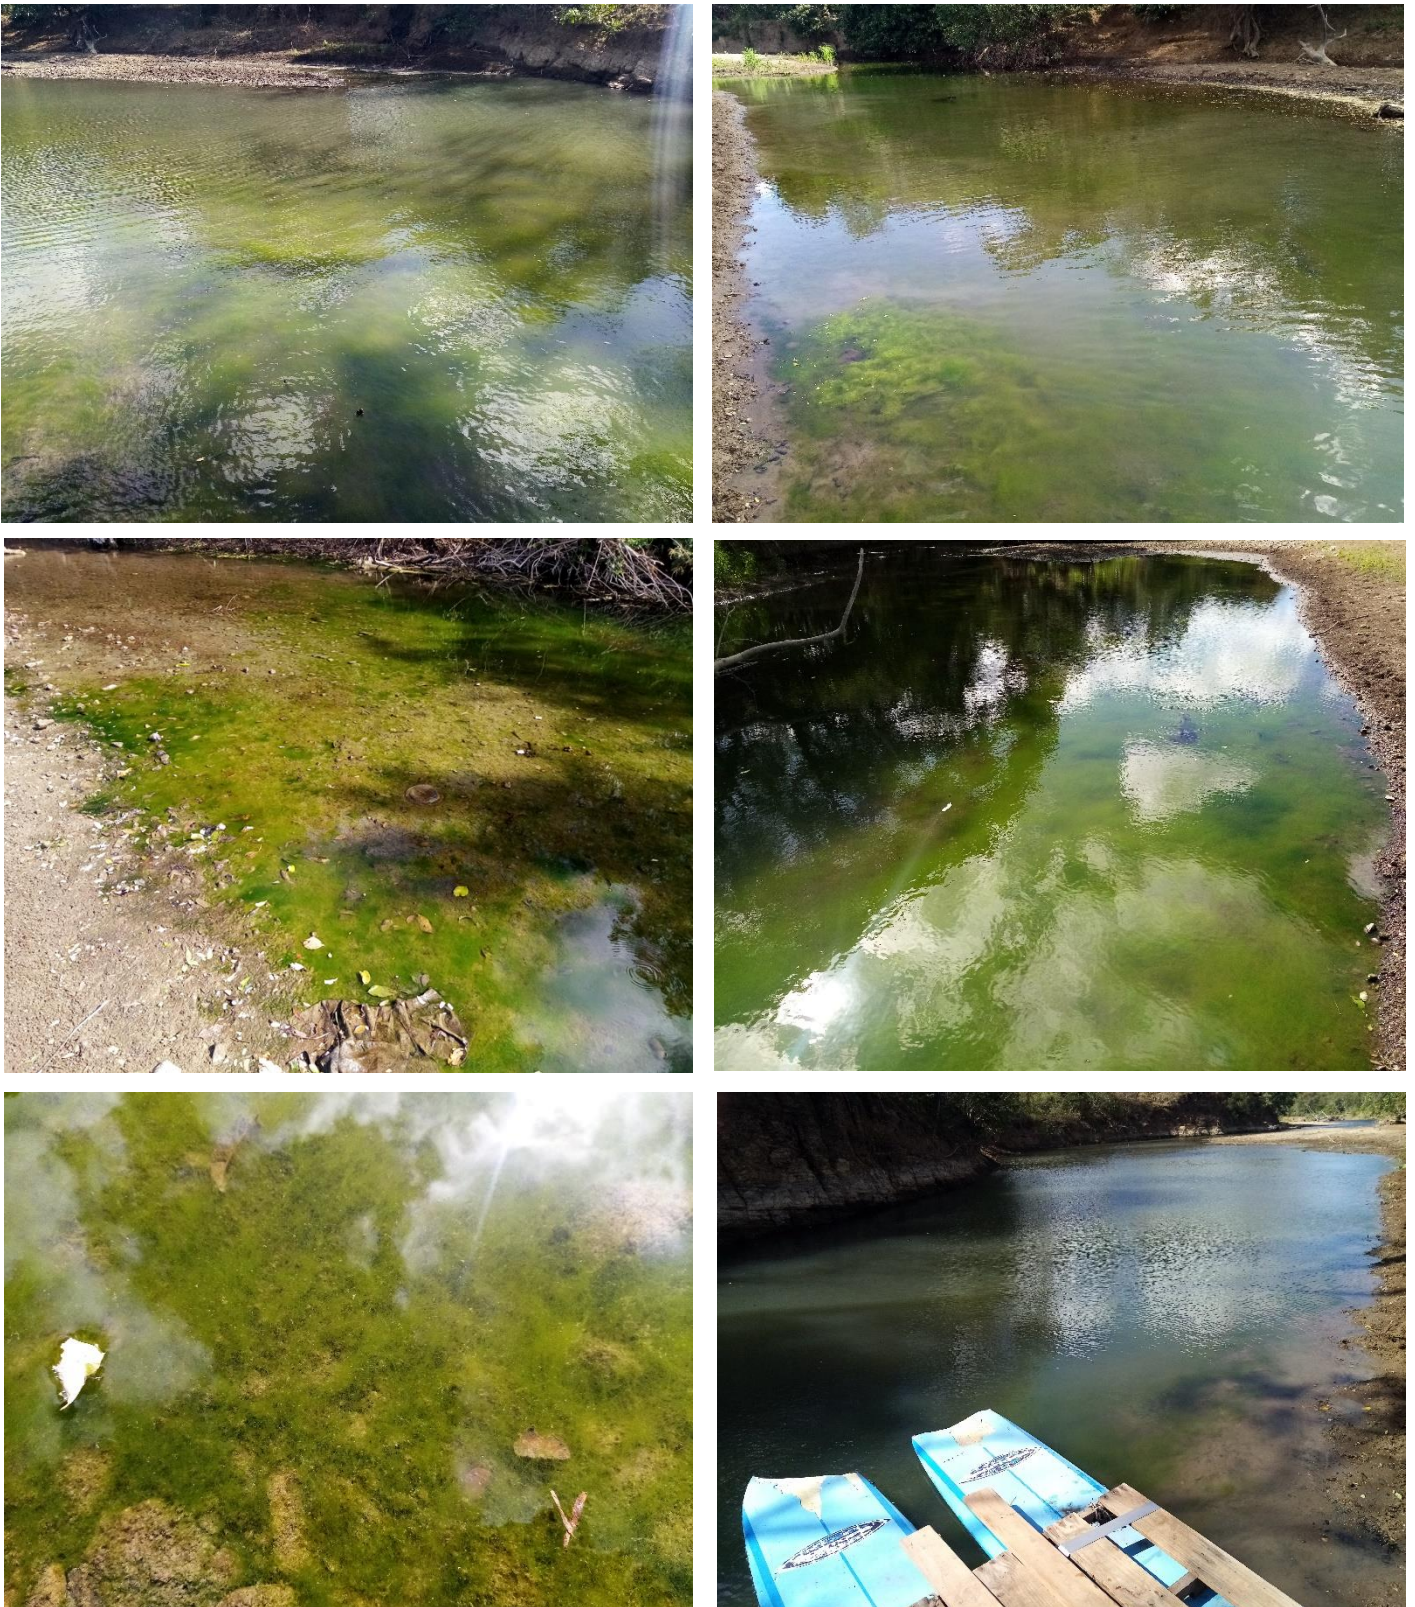
Figure19. Pictures showing the hypereutrophic state of the river Rio escalante. Algae overgrowth can be seen from the distinct green coloration of the water body.

The river Rio Escalante is in a hypereutrophic state according to the Trophic State Index. This is a worrying situation for the ecosystem and the people of the community. Indeed, toxic algae events have been registered in the area before and many cases of Paralytic Shellfish Poisoning happened. However, measures can be taken to improve the situation. On one hand, through informative lectures/workshops in the community about the environmental impact of detergent used directly in the water. On the other hand, the fertilizer use of farmers should be reduced to tackle the nutrient pollution at its source and to improve the river quality in the future.

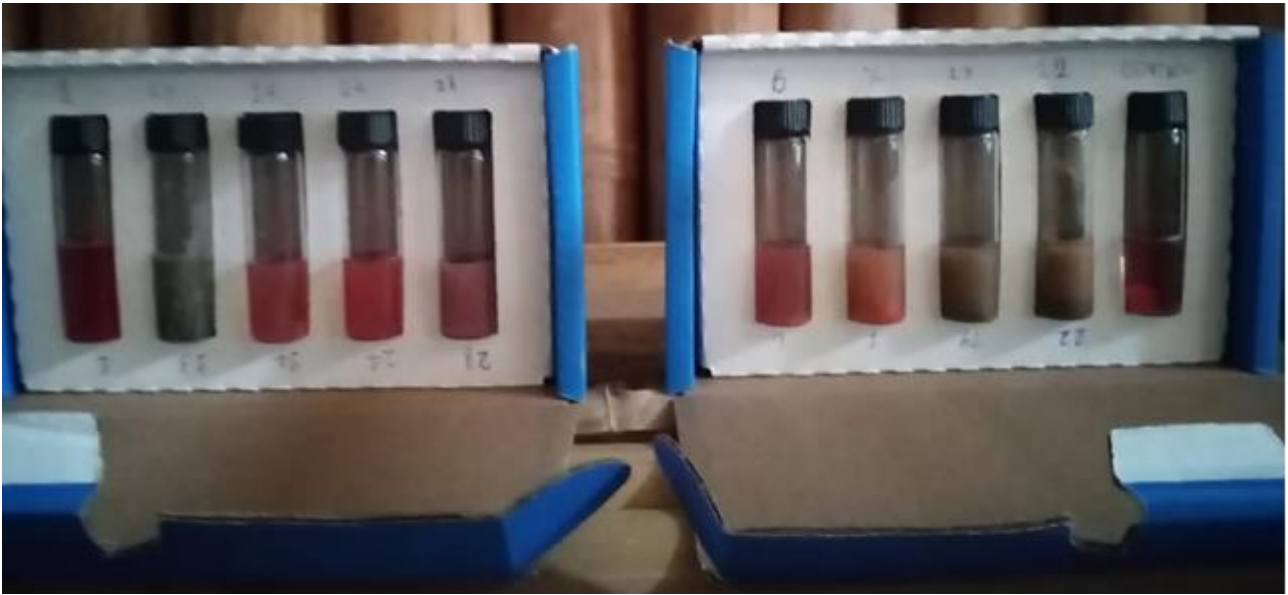
Figure 20. Total Coliform samples taken at  $T_0$ , start of the incubation time. The last sample on the right is the control. Numbers refer to the geographic marked location point in the GPS map. Test kits from "La Motte Ltd."

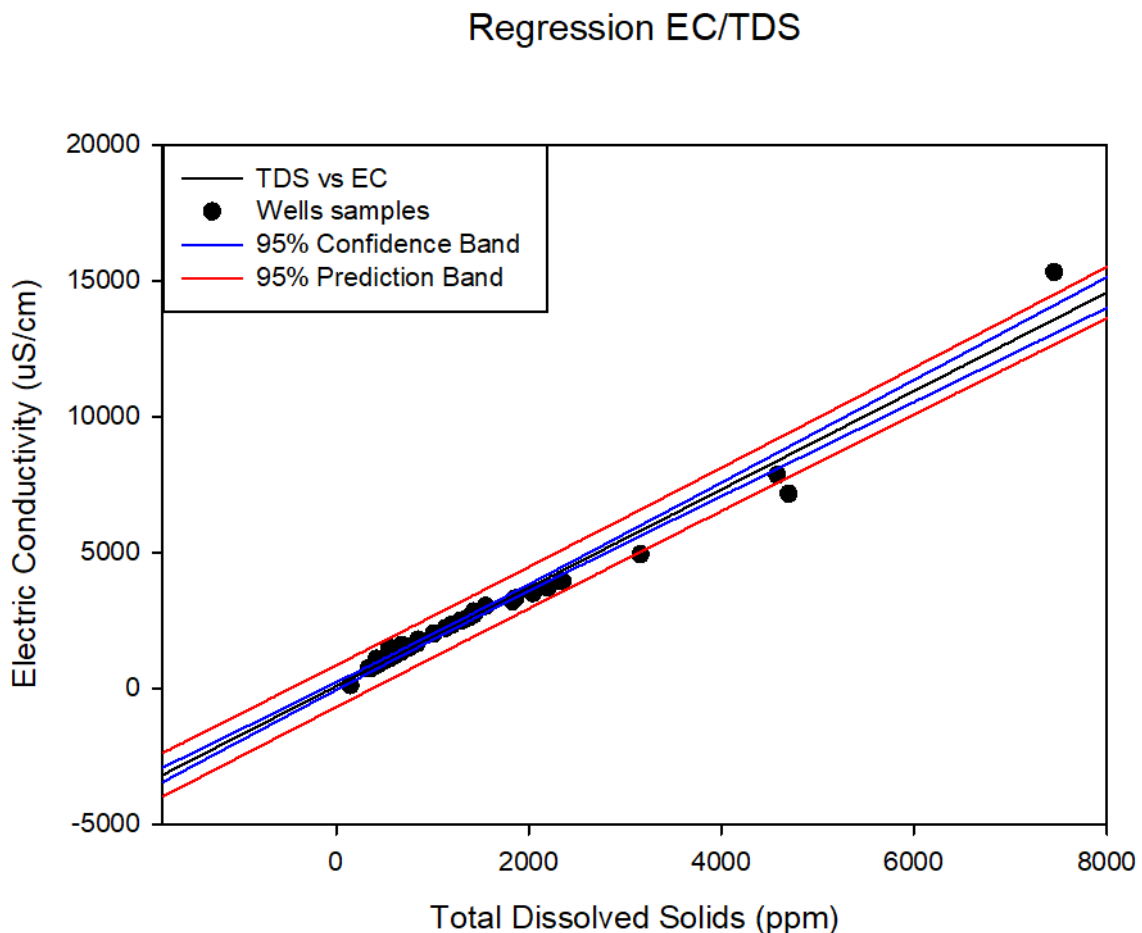
Figure 20. Regression EC/TDS for the wells samples data  $n=60$

Results from the regression, obtained with the data of the wells' samples  $n = 60$ , show a strong positive linear relationship with a correlation of  $r = 0.98$  (fig.20). The correlation factor is on average 0.52.
